# What to look out for

A guide to common possible building defects from your specialist building inspectors, **Betta Inspect It.**

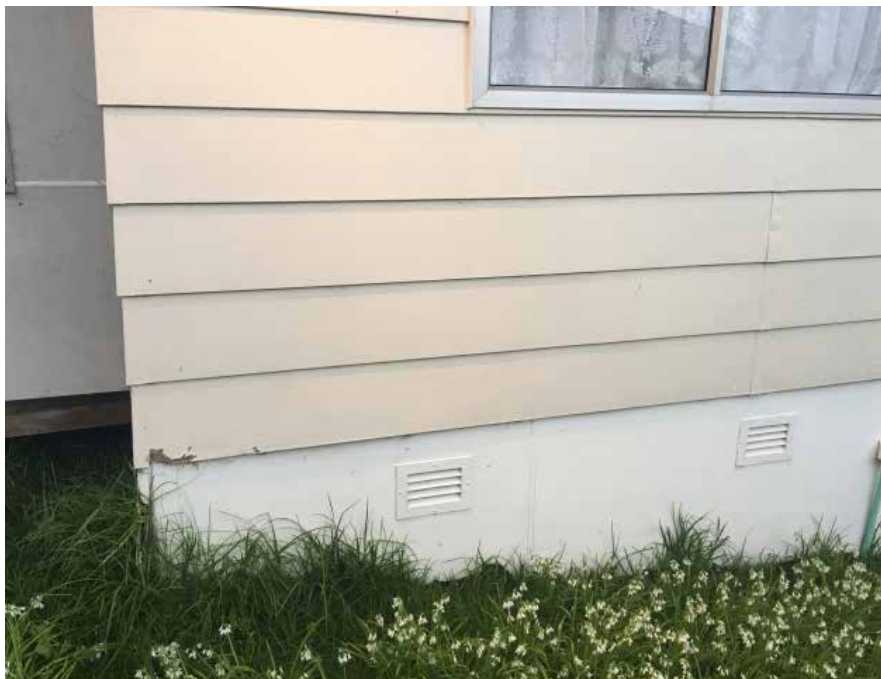
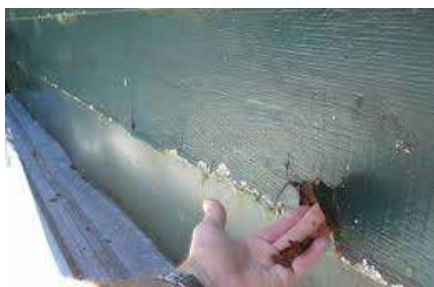
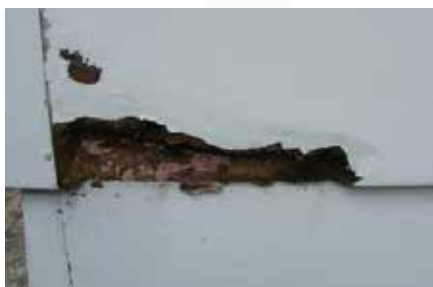
Photos of Oil Tempered Hardboard ('Weatherside')

1. **Rot.** Usually around nail holes and joints, as well as chipping along the bottom edges of planks (approx 10c coin size). Rot is most common on the lower three or four boards and / or on the damp side of a house.
2. **Bevel.** Oil Tempered Hardboard has a more bevelled edge than Hardiplank.
3. **Colour.** If you scratch the paint off Oil Tempered Hardboard you'll see a brown fibre-cement material. Hardiplank will be grey.
4. **Size.** Both Hardiplank and Oil Tempered Hardboard are identical in width at 240mm but Oil Tempered Hardboard is 10mm thick whereas Hardiplank is 7.5mm thick.
5. **Sound.** When tapping boards Oil Tempered Hardboard sounds more hollow than Hardiplank.
6. **Joints.** The joiners between planks are usually metal not plastic and wider than Hardiplank joints.

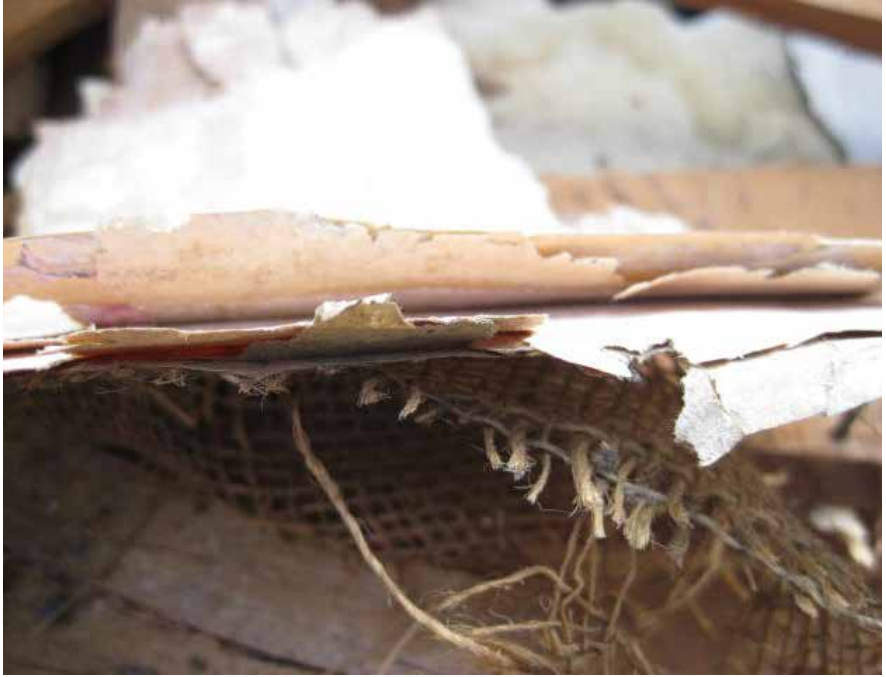
Layers of wallpaper on scrim.

**3. Close inspection.** You can sometimes see rough sawn board (sarking) or hessian (scrim) where wallpaper is loose or has come away. Or, the wallpaper may look 'textured' as the woven hessian fabric has imprinted into the wallpaper from behind.

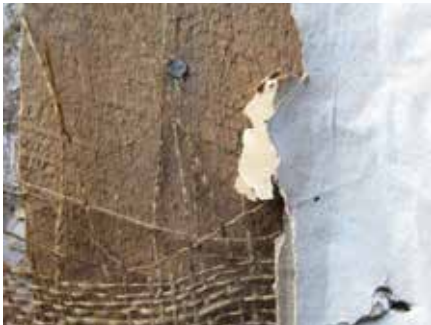
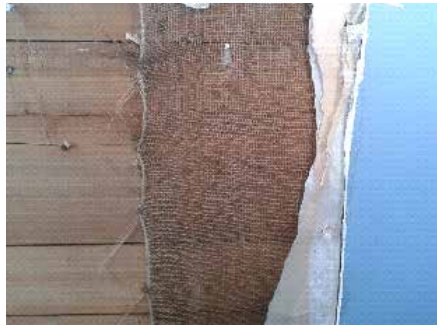
Sarking boards, scrim and wallpaper.

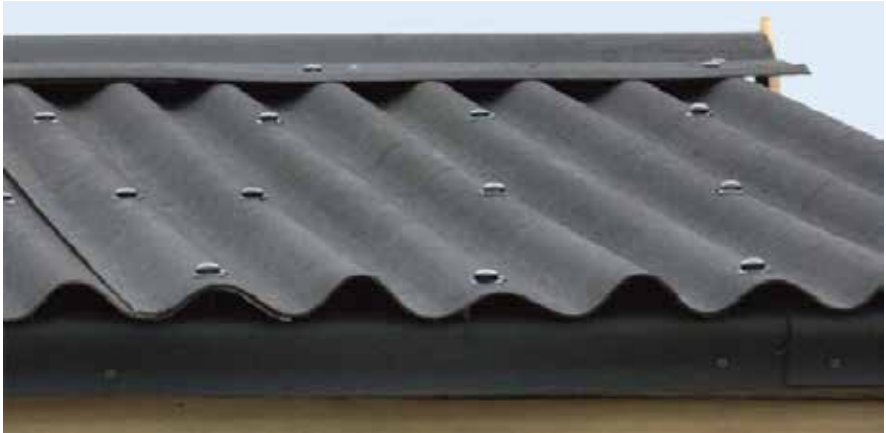
Photos of Onduline.

1. **Age.** Onduline first came on the market in New Zealand during the early 1990s and was used widely during this time, particularly in coastal communities. It exited the market in the mid 2000s.
2. **Corrugations.** Onduline was manufactured as a corrugated profile (just like corrugated iron) but with much larger troughs (like the old asbestos roofing).
3. **Thickness.** Onduline is also a lot thicker than typical corrugated iron roofing.
4. **Look.** Onduline is not completely smooth. You'll be able to see the fibres, unlike corrugated iron roofing, which is smooth.

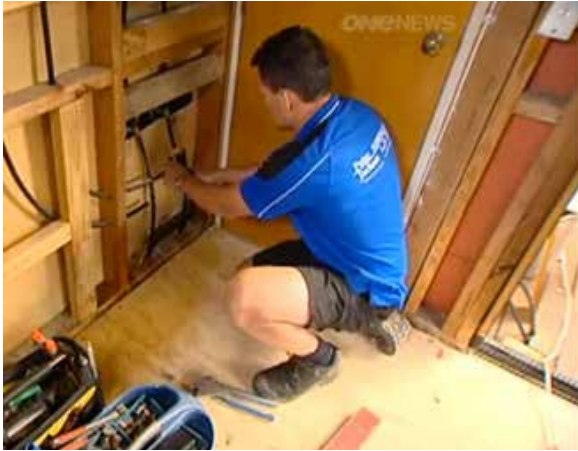
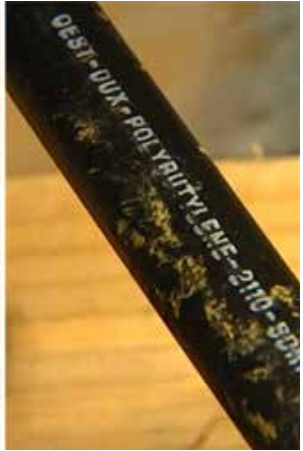
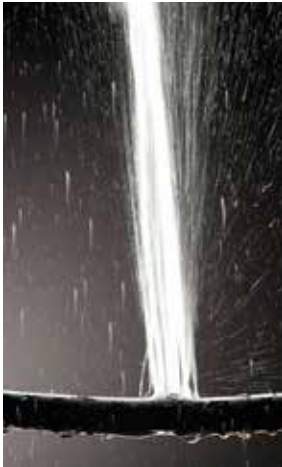
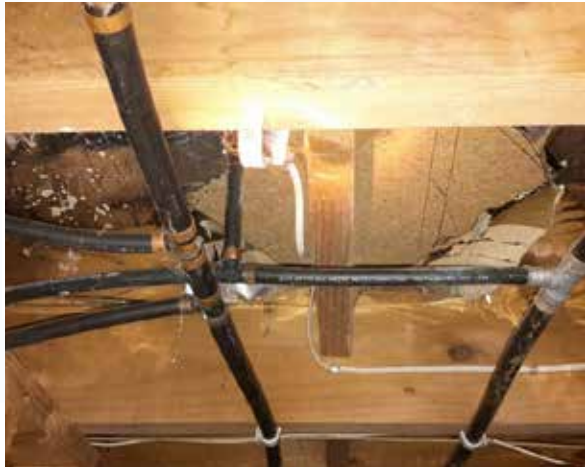
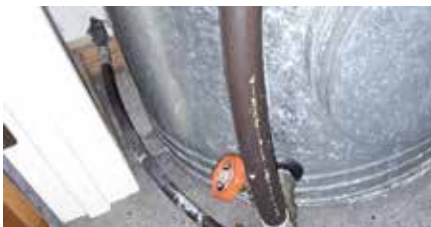
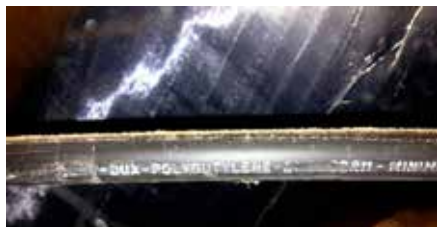
Dux Quest plumbing.

- **Colour.** It's black.
- **Look.** It looks like plastic and is similar to the piping used for garden sprinkler systems.
- **Age.** The period the house was built: 1970-1989 approximately.
- **Branding.** There is often Dux Quest (or Quest) written in white along some sections of the pipe.

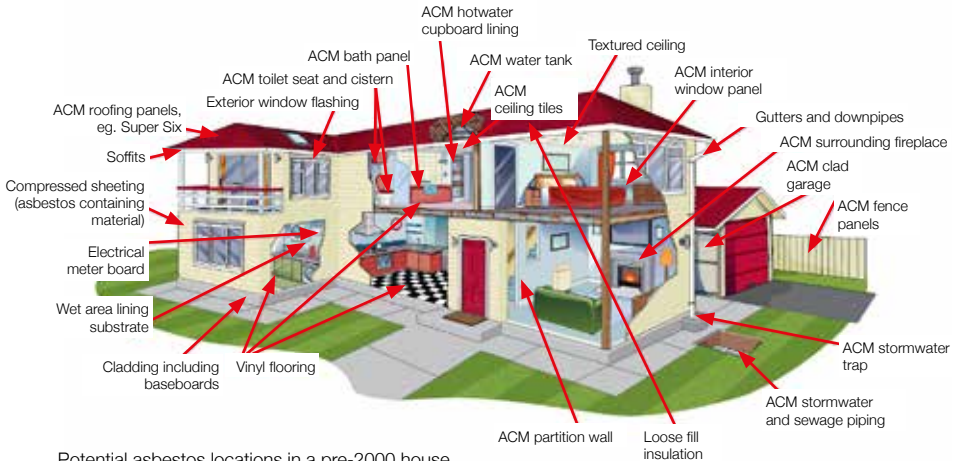
Potential asbestos locations in a pre-2000 house.  
 Source: Asbestos – Invercargill City Council.

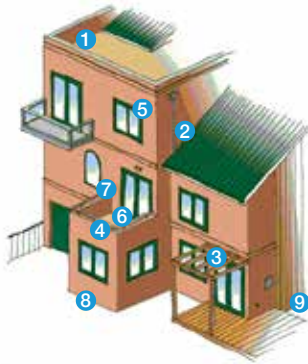
Common risk areas in a house.  
Elements numbered on page 16.  
Source: BRANZ Weathertight.

- Sagging of ceiling linings.
- Corrosion of fixings such as screws and nails.
- Uneven floor surfaces, like the lifting of vinyl.
- Mould or fungi formation on surfaces (although this can also be due to poor ventilation).
- Musty smells.
- Swollen materials such as skirting and architraves.
- Staining or discolouration of materials or surfaces.
- Stained or rotting carpet, or rusting of carpet fixings.
- Cracking in plaster.

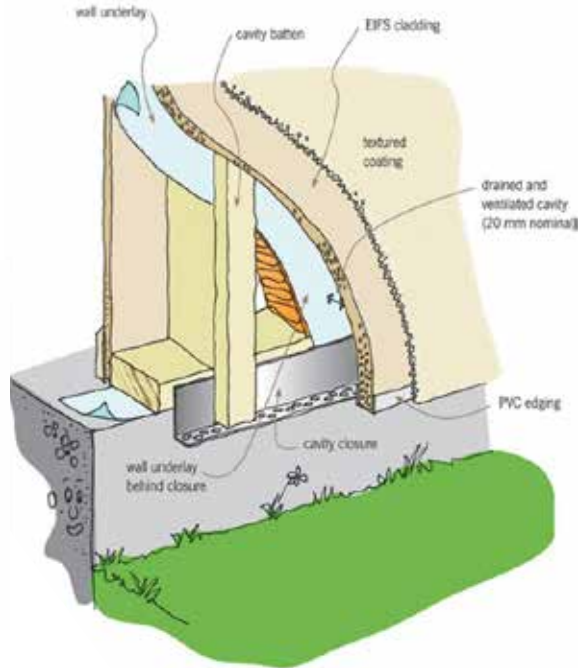
New building Method – with a cavity.  
Source: BRANZ Weathertight.

- 1. Deflection.** Water is primarily deflected by the cladding.
- 2. Drainage.** Water must be able to drain off roof and wall surfaces, and any water that penetrates the cladding must also be drained back out from within the cladding assembly.
- 3. Drying.** Air needs to be able to circulate within wall assemblies to dry water absorbed by components, and wind and sun will dry water off the cladding exterior.
- 4. Durability.** All components of a cladding and wall assembly need to be appropriately durable for the relevant conditions and New Zealand Building Code durability requirements.
